## ZÁVAZNÝ SERVISNÍ BULETIN / MANDATORY SERVICE BULLETIN

TÝKÁ SE / CLARIFICATIONS: Damage to the flap drive torque tube in the fuselage.

OVLIVNĚNÉ VÝROBKY / AFFECTED PRODUCTS: TL 3000 Sirius serial numbers

ČÍSLO BULETINU / NOTICE ID: 3.S.SI.2017

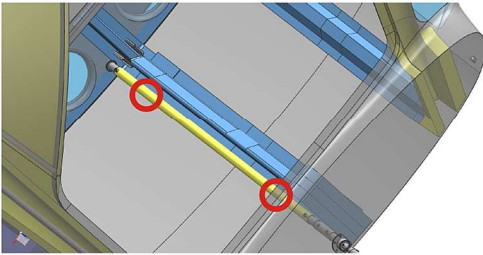
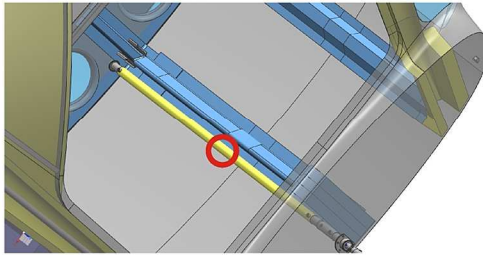
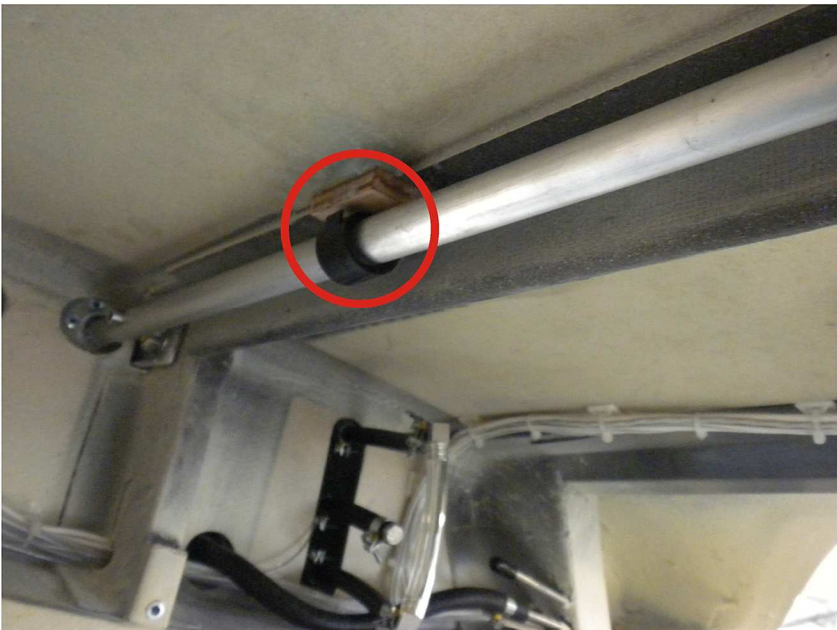
Sequence of steps	Description of Operation
<p style="font-size: 2em; font-weight: bold;">5</p>	<p style="font-weight: bold;">Inspection of the torque tube</p> <p>- Inspect the flap drive torque tube for the presence of damage at the location of the fixed plastic support (1 or 2 depending on the aircraft type).</p> <div style="display: flex; justify-content: space-around; margin-top: 20px;"> <div style="text-align: center;"> <p>variant A</p> <p>2 supports at either side of the tube.</p>

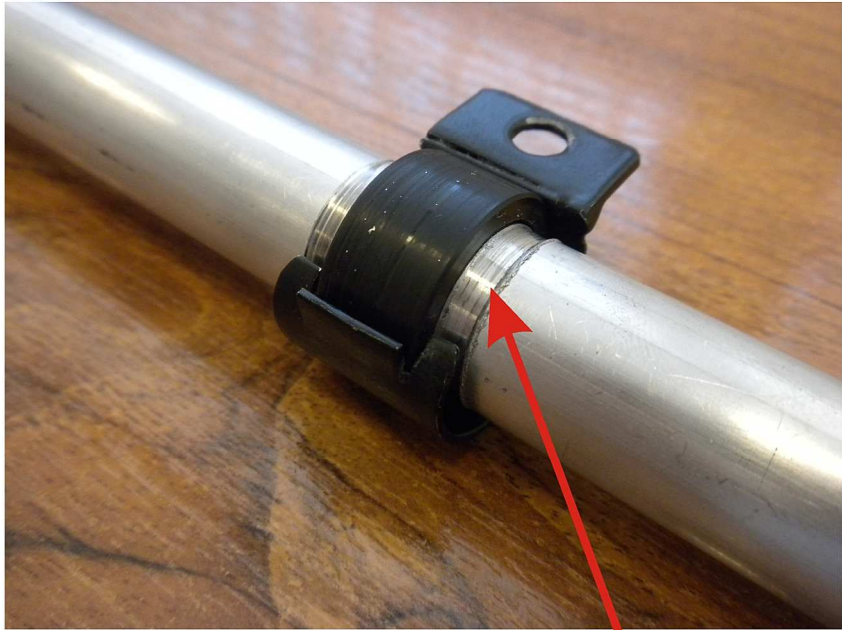
<p data-bbox="316 1182 895 1223">Damage/groove in flap drive torque tube</p>

Sequence of steps	Description of Operation
	<p>- If damage to the torque tubes is found (signified by grooves in the surface of the tube) the take off is prohibited. Dismantle the flap drive torque tube along with the retaining plate and sliding guide. Contact the aircraft manufacturer immediately about your findings. Consequently, the manufacturer will replace the removed parts with newly supplied spare parts.</p> <p>- If the outside diameter of the flap drive torque tube which is fixed within the bracket is smaller in size by 0.15 mm or more when compared to the outside diameter of the torque tube outside the bracket, then the torque tube, including brackets, is to be considered as damaged and must be replaced.</p>
<p><b>6</b></p>	<p><b>Record of the completed bulletin requirements</b></p> <p>- Complete the record for aircraft documentation with regards to the performance bulletin. Complete the record in the following manner:</p> <p style="padding-left: 40px;">Inspected under the mandatory service bulletin 3.S.SI.2017.                      Inspection revealed no damage and no further action is required/revealed damage to the flap drive torque tube and parts were exchanged according to the instructions in the bulletin. The aircraft is capable of continued operation.</p> <p>Date:</p> <p>Inspection completed by:                      Signature</p>

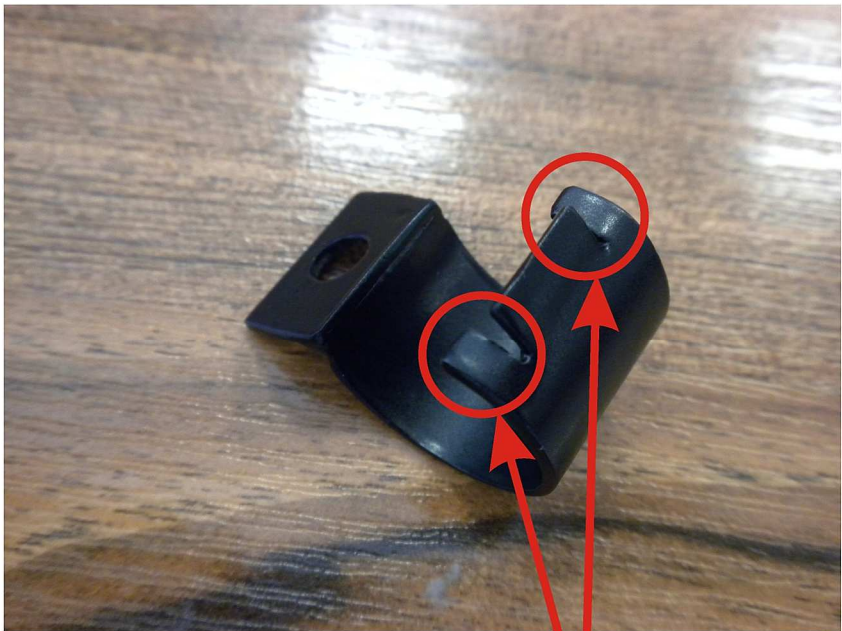
The shape of the metal that holds the sliding mount ensures the axial position of the sliding bearing that is fitted over the torque tube. Excessive bending of the two metal safeguards can lead to contact between the locking part of the metal and the rotating torque tube (especially at high speed rotation of the torque tube). This, in combination with the tube's rotation, creates a groove along the circumference of the tube that weakens its cross-section and load capacity.

<p data-bbox="304 1935 1353 2029"><b>The metal lugs on the support, which is used to grip the flap drive torque tube, may be excessively bent, causing operational damage to the torque tube.</b></p>
