## ZÁVAZNÝ SERVISNÍ BULETIN / MANDATORY SERVICE BULLETIN

TÝKÁ SE / CLARIFICATIONS: Installation of the fuse for the flap control servo-motor.

OVLIVNĚNÉ VÝROBKY / AFFECTED PRODUCTS: All TL 3000 Sirius aircraft furnished with the flap control system unit - Flopcontrol OPA

ČÍSLO BULETINU / NOTICE ID: 1.S.SI.2014

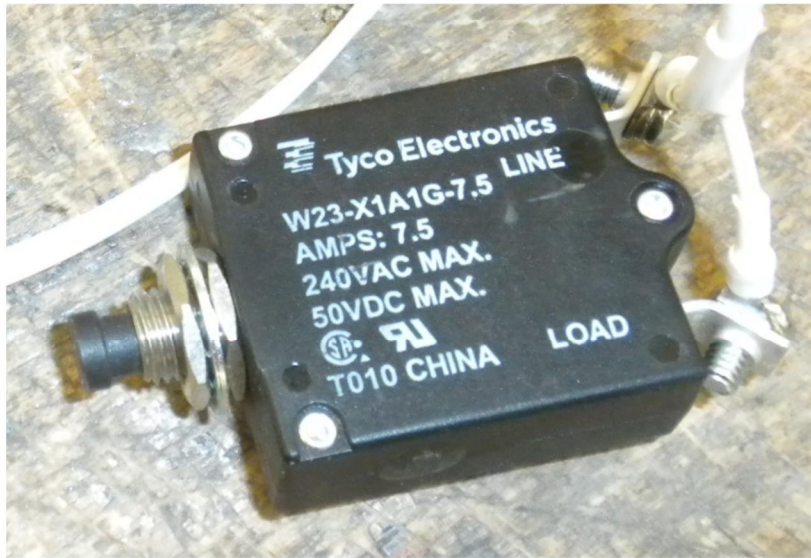
7,5 A fuse Tyco Electronics W23-X1A1G-7,5

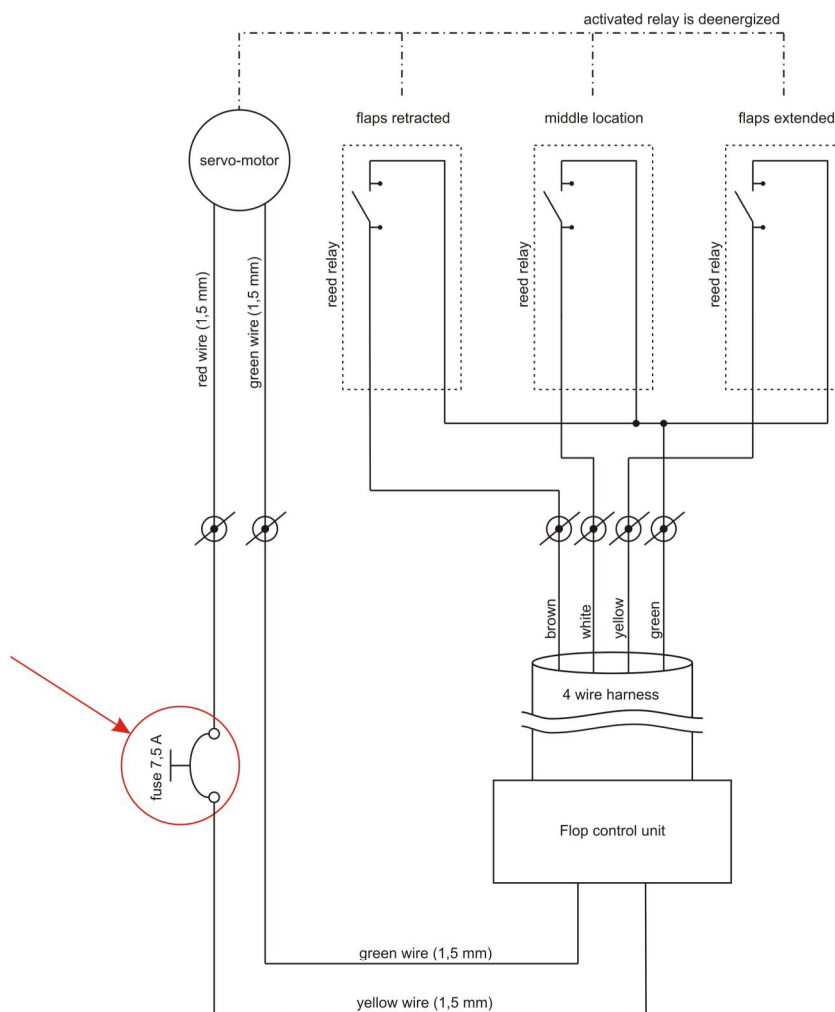
Diagram illustrating the insertion of the 7,5 A fuse into the flap control electrical circuit
