ZÁVAZNÝ SERVISNÍ BULETIN / MANDATORY SERVICE BULLETIN

TÝKÁ SE / CLARIFICATIONS: Replacing the brake disc top hat washers in the main landing gear hub.

OVLIVNĚNÉ VÝROBKY / AFFECTED PRODUCTS: All TL 2000 and TL 3000 aircraft with main landing

ČÍSLO BULETINU / NOTICE ID: 2.S.SI ST.2015

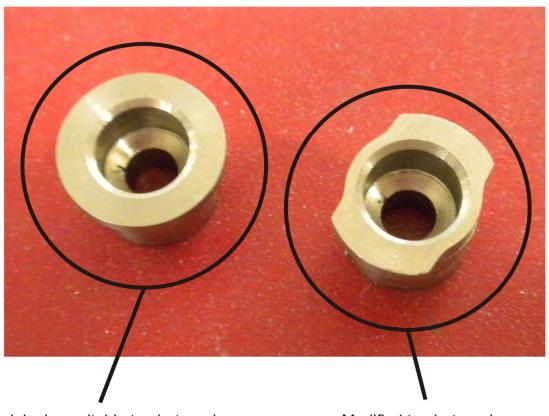
The original unsuitable top hat washer (necessary to replace with the modified option)

Modified top hat washer

As a solution to this condition, the TL-ULTRALIGHT suggests the replacement of the six original top hat washers on each wheel with the new version of top hat washers. At the same time, it is also necessary to replace the M5x12 screws for the shorter M5x10 screws, with which the washers are attached to the wheel hub. This modification will allow for a better leeway space between the critical parts of the wheel, preventing their contact prior to reaching the permitted brake pad wear limit.
