## ZÁVAZNÝ SERVISNÍ BULETIN / MANDATORY SERVICE BULLETIN

TÝKÁ SE / CLARIFICATIONS: Damage to the flap drive torque tube in the fuselage.

OVLIVNĚNÉ VÝROBKY / AFFECTED PRODUCTS: TL 3000 Sirius serial numbers

ČÍSLO BULETINU / NOTICE ID: 3.S.SI.2017

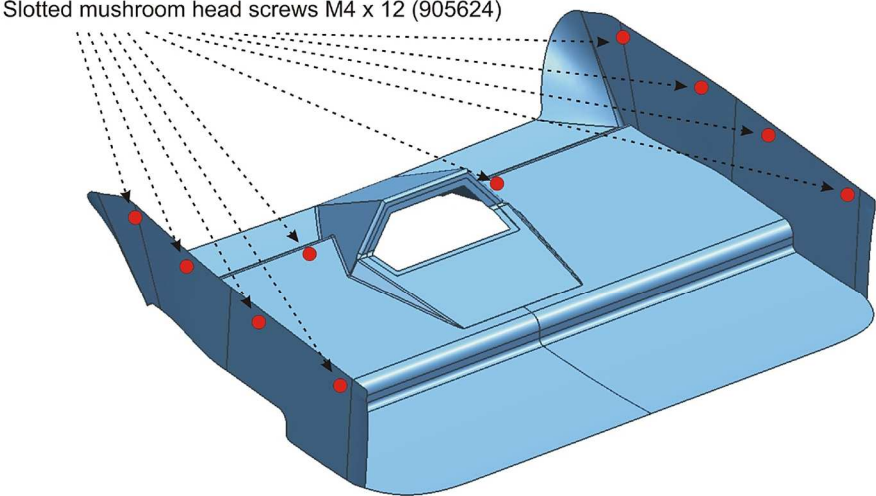
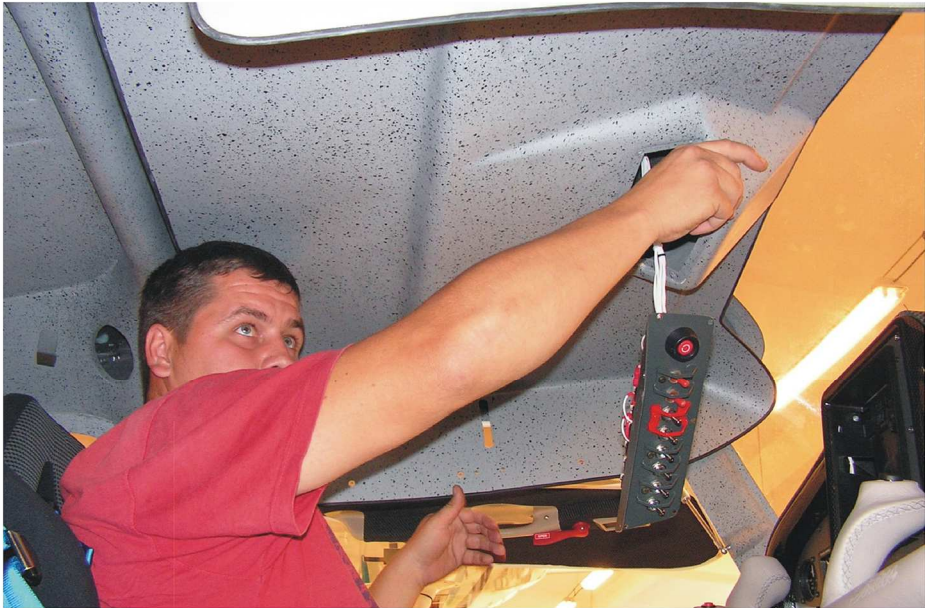
</div> <p>- After removal of the ceiling panel, the flap drive torque tube is open for inspection</p>

Sequence of steps	Description of Operation
<p style="font-size: 2em; font-weight: bold;">4</p>	<p style="font-weight: bold;">Dismantling the composite ceiling panel</p> <p>- Remove the composite ceiling panel. The panel is attached to the aircraft with M4x12 bolts and Velcro strips.</p> <div style="text-align: center;"> <p>Slotted mushroom head screws M4 x 12 (905624)</p>
