ZÁVAZNÝ SERVISNÍ BULETIN / MANDATORY SERVICE BULLETIN

TÝKÁ SE / CLARIFICATIONS: Replacing the brake disc top hat washers in the main landing gear hub.

OVLIVNĚNÉ VÝROBKY / AFFECTED PRODUCTS: All TL 2000 and TL 3000 aircraft with main landing

ČÍSLO BULETINU / NOTICE ID: 2.S.SI ST.2015

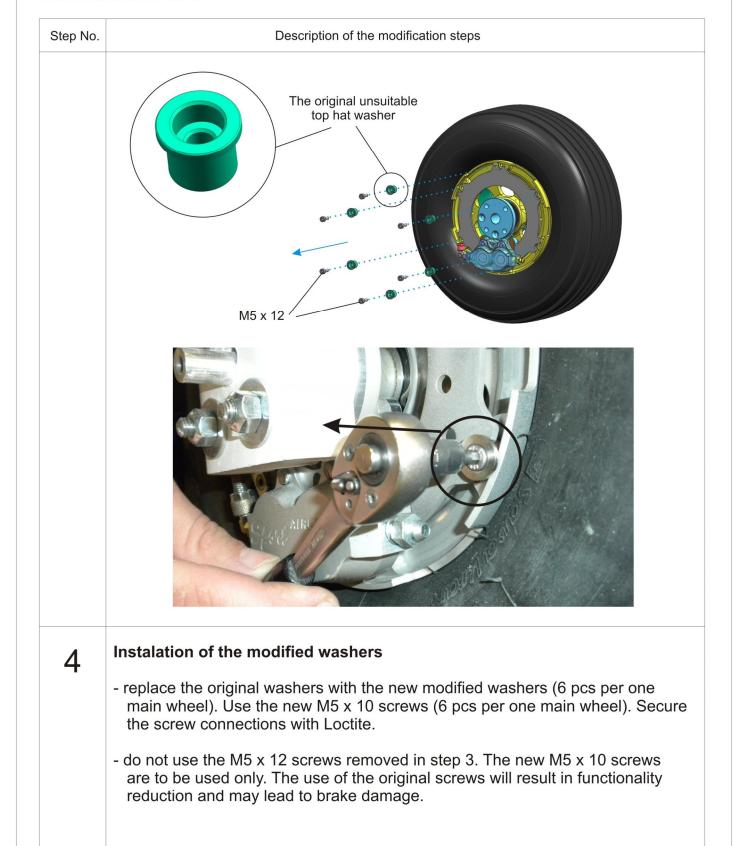
During the operation of the TL 3000 Sirius and the TL 2000 Sting fleet of aircraft that have been fitted with the main landing gear wheels with the brake disc top hat washers in the main landing gear hub, it was found that with an overall brake pad wear exceeding 3 mm, the contact between the rotating washers in the wheel hub and the brake caliper pistons could occur.

As a solution to this condition, the TL-ULTRALIGHT suggests the replacement of the six original top hat washers on each wheel with the new version of top hat washers. At the same time, it is also necessary to replace the M5x12 screws for the shorter M5x10 screws, with which the washers are attached to the wheel hub. This modification will allow for a better leeway space between the critical parts of the wheel, preventing their contact prior to reaching the permitted brake pad wear limit.

This SB contains a step by step main landing gear wheels modification manual, so that it can be correctly performed by the aircraft operator. It is not necessary to dismantle the wheel to perform the SB. Removal of the wheel fairings will be required only.

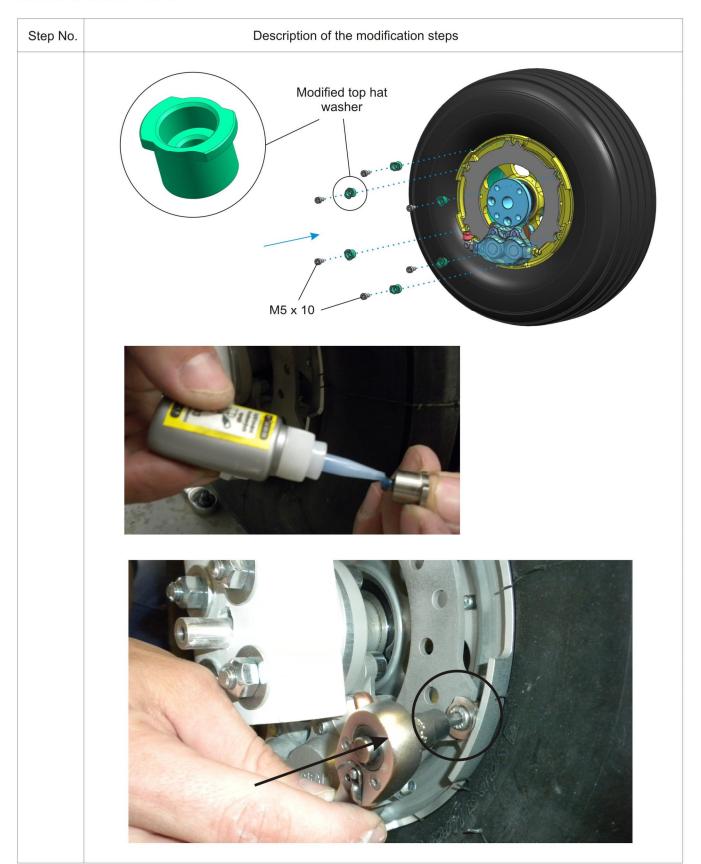
The original unsuitable top hat washer (necessary to replace with the modified option)
